Field Report for Airborne Data Collected In Support of US EPA Region 6 Intercontinental Terminals Company LLC Fire 26 March 2019

Data Results Flight 13, 26 March 2019

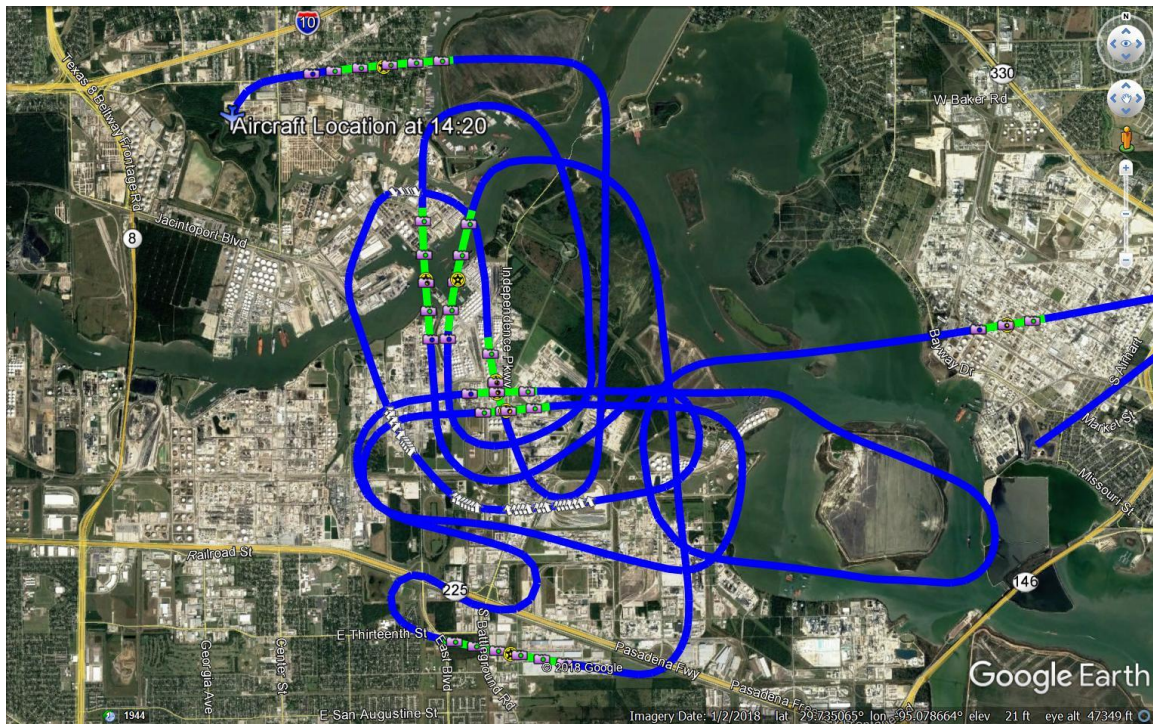
Figure 2: Flight line data for 26 March 2019, Flight 13. The blue lines represent the ASPECT flight path, green lines represent when the Infrared Line Scanner was actively collecting data, and the camera icons represent when a photo was taken.

The order to launch the aircraft was given at 0830 local on 26 March 2019 and the aircraft was airborne at 0840. The initial data collection run over the site was at 0854 (local) and the aircraft made a total of 7 data collection passes. No detections were observed on any passes. Flight information is summarized in Appendix A and Figure 2.

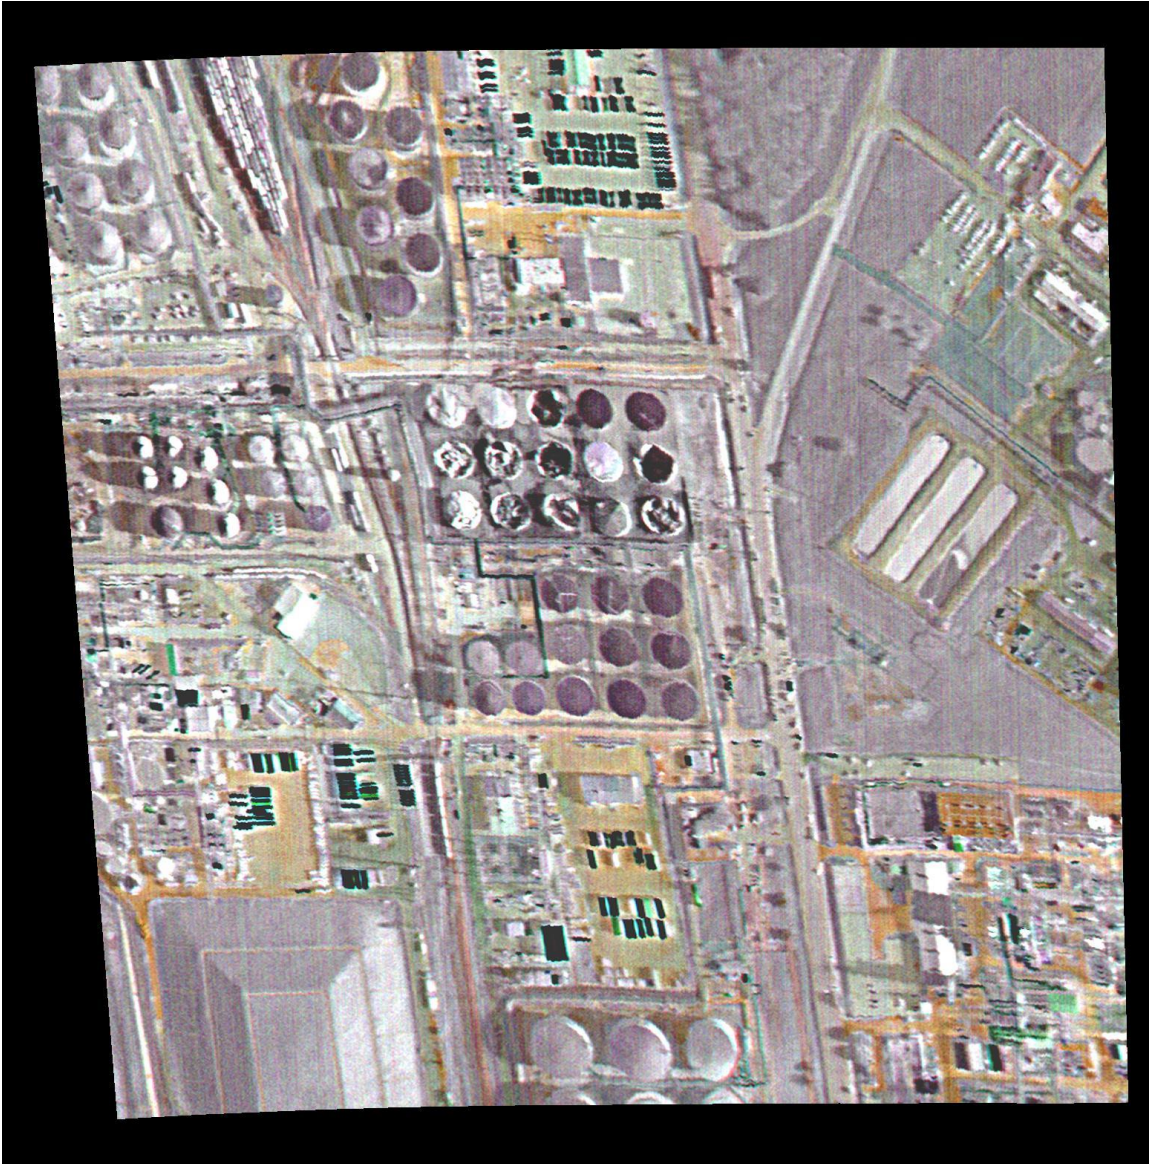
A total of 1 test and 7 data passes were made in the proximity of the impacted tank farm and also in extended areas surrounding the site and infrared line scanner images were generated for each pass. Figure 3 shows a typical 3-band infrared image obtained from data collected for Run 2. The image tends to show more surface detail on the tanks in the NM portion of the tank farm due to less detector saturation. This effect supports that the temperature of the tanks is close to ambient with heating likely due to solar radiation. A night vision thermal image supports this observation with clear surface details showing in the far NW tank and to a lesser degree that tank located to the east (bottom right in the image is the NW due to the image being inverted)(Figure 4).

Figure 3: IR image of ITC data for 26 March 2019, Flight 13 Run 2

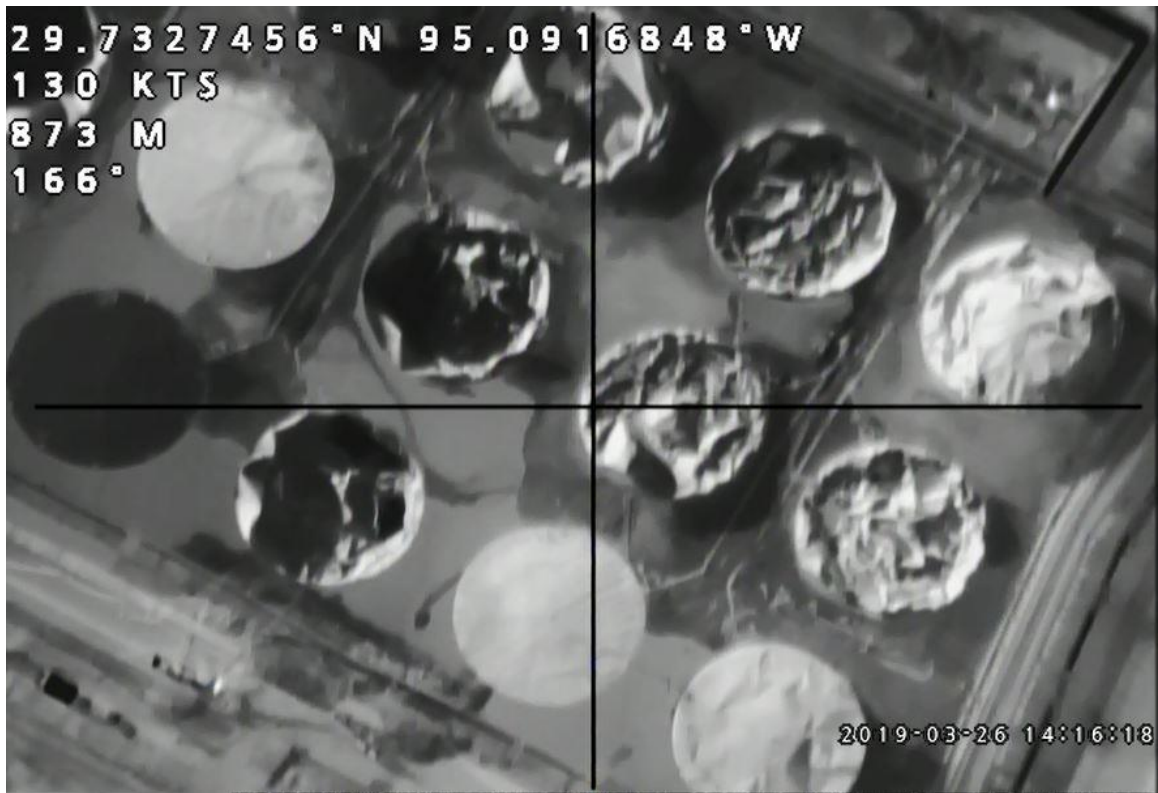
Figure 4: IR Thermal Analysis 26 March 2019, Flight 13, Run 7

ASPECT conducted flight 12 on 26 March 2019 with the goal to conduct a general survey at the tank farm and downwind of the site. Imagery collected on this flight indicates that the NW tanks in the tank farm are cooler than on previous flights. IR data collected over the confluence into the ship channel continues to show sheen in the waterway. Similar analysis of visible imagery tends to show much less sheen. No significant chemical detections were observed on this flight.

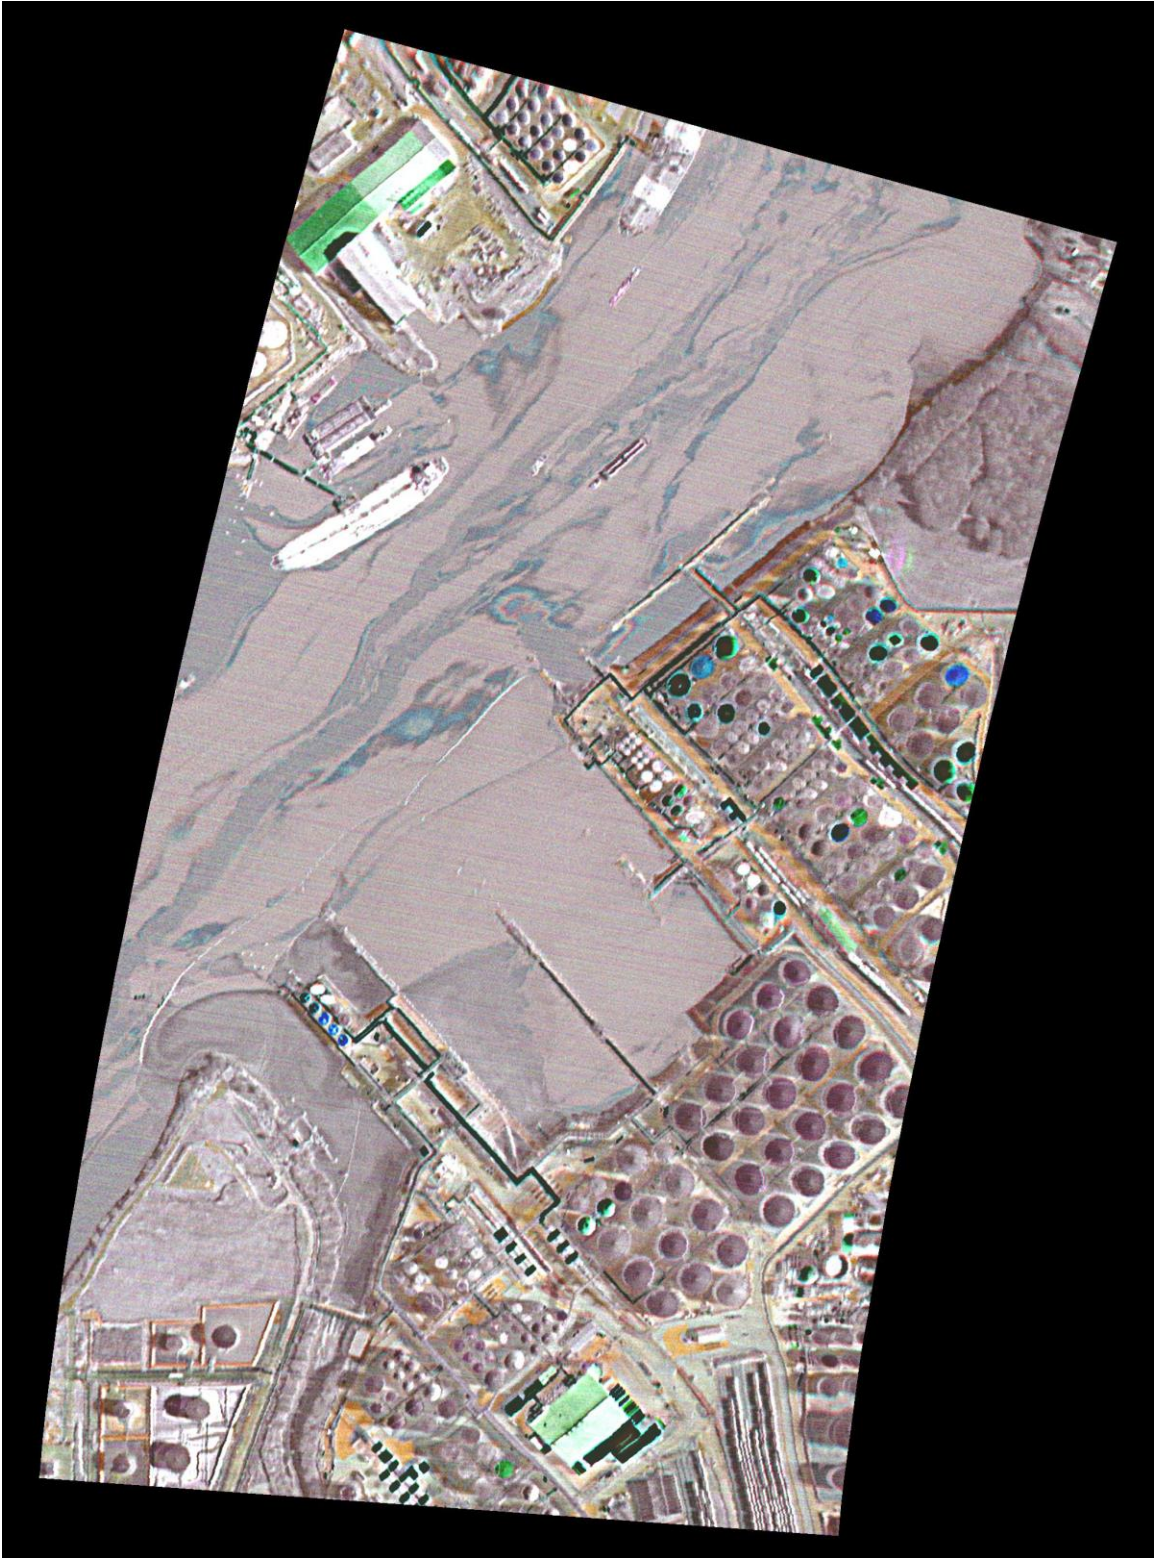
IR Run 5 was conducted over the confluence of the drainage creek into the ship channel. Containment boom (white due to solar heating) can be seen across the channel mouth and also upstream within the drainage channel. Sheen leakage is very apparent in the image and is present in the entire field of view of the image (Figure 5).

Figure 5: IR Image of Contained Oil 26 March 2019, Fight 13, Run 5

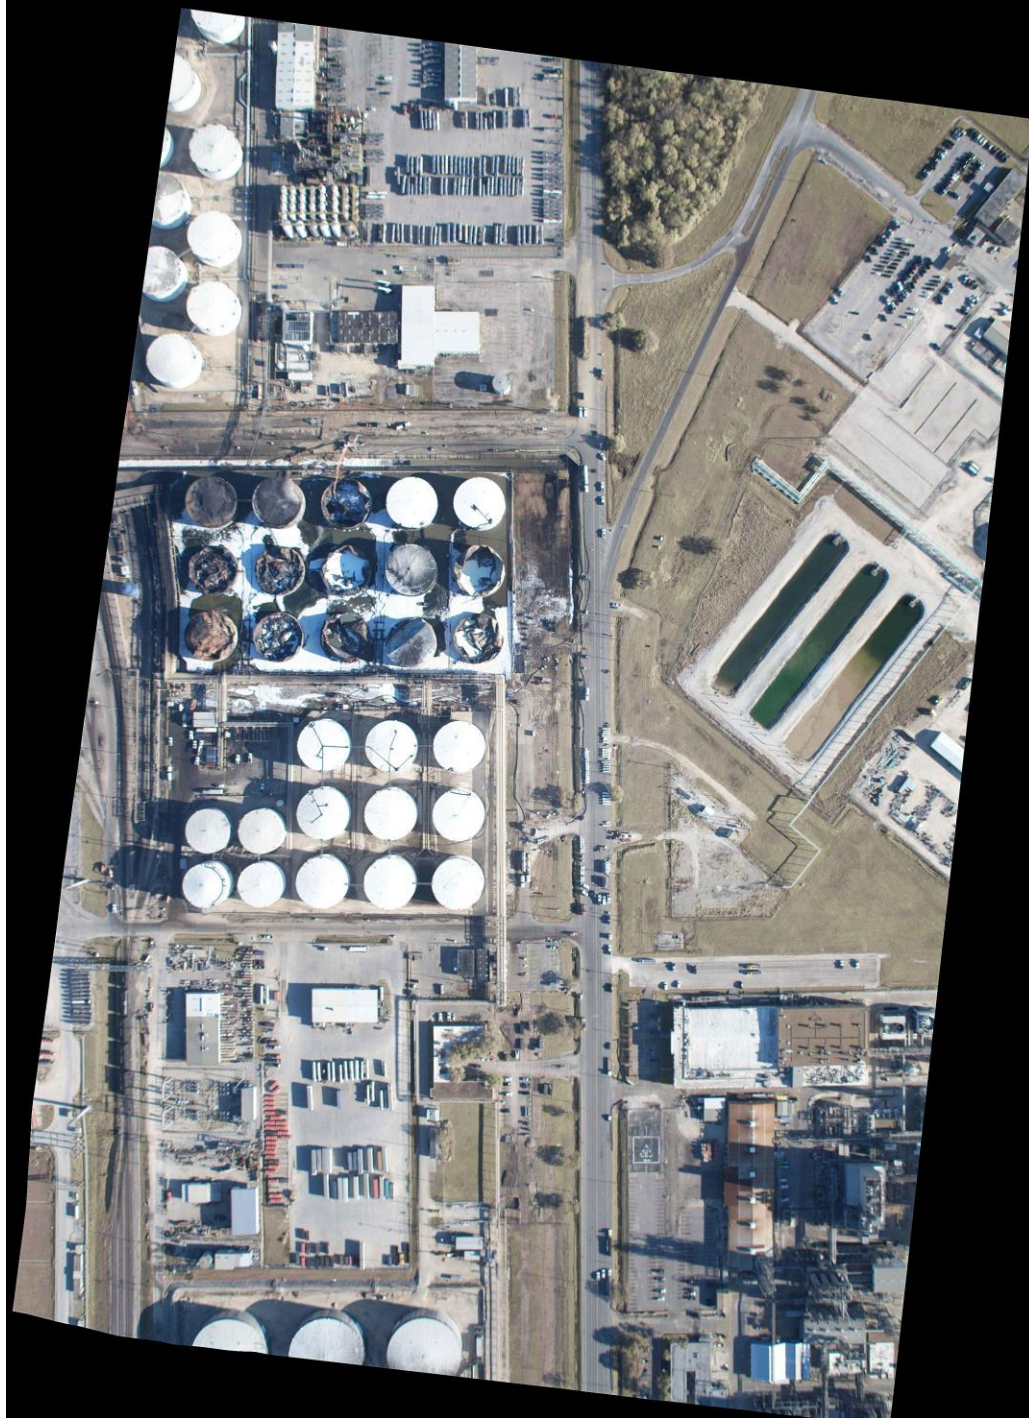
A full set of high resolution aerial digital photography was collected as part of the flight. Figure 6 shows a representative overhead image collected as part of each pass over the tank farm. Damage to the tanks is clearly evident as is the continued presence of white material in the secondary containment. Figure 7 provides an overhead view of the confluence area with the boom structure evident. Some product and sheen can be seen but differentiation of these materials is less apparent in the visible image as compared to the IR. Figure 8 shows the same area but from the perspective of an oblique image. Differentiation of project is more robust as compared to the overhead with limited evidence of sheen.

Figure 6: Aerial Image of the Tank Farm, 26 March 2019, Flight 13

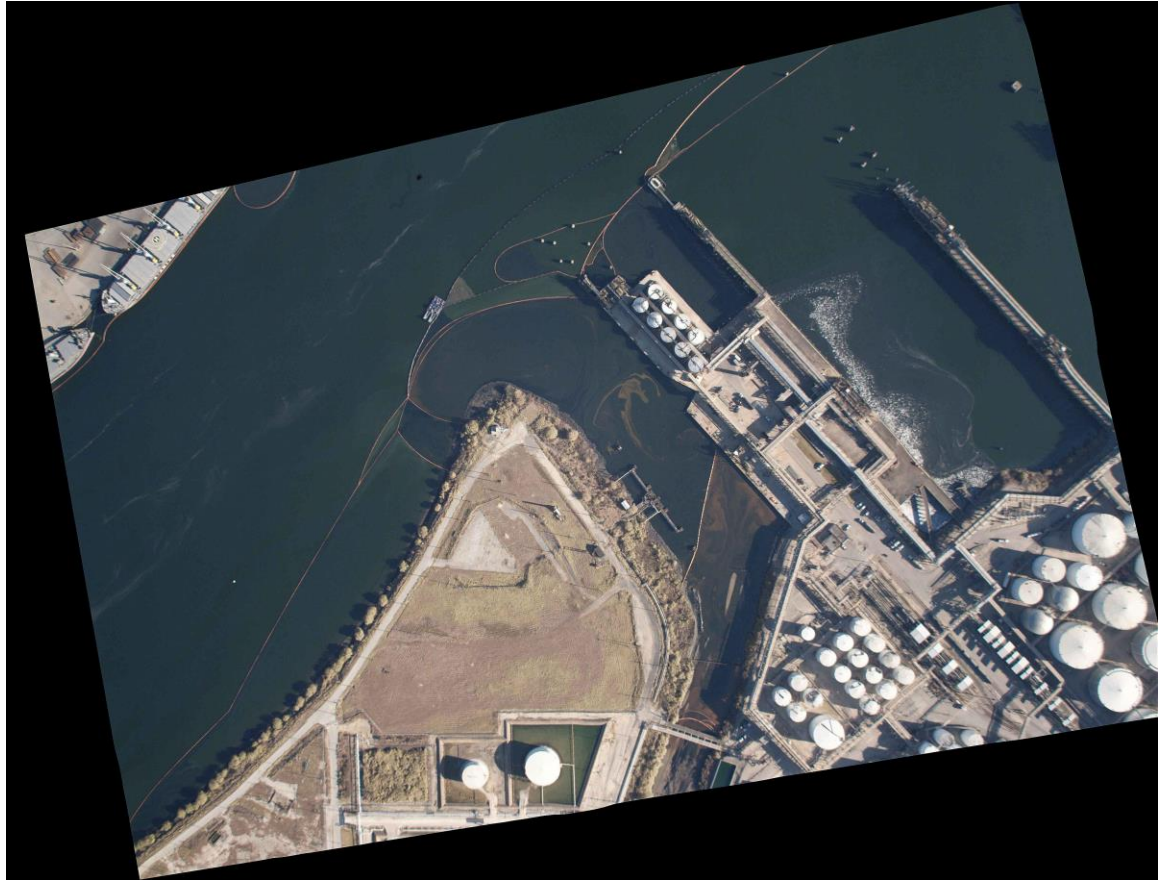
Figure 7: Aerial Image of the Ship Channel Boom Area, 26 March 2019, Flight 13

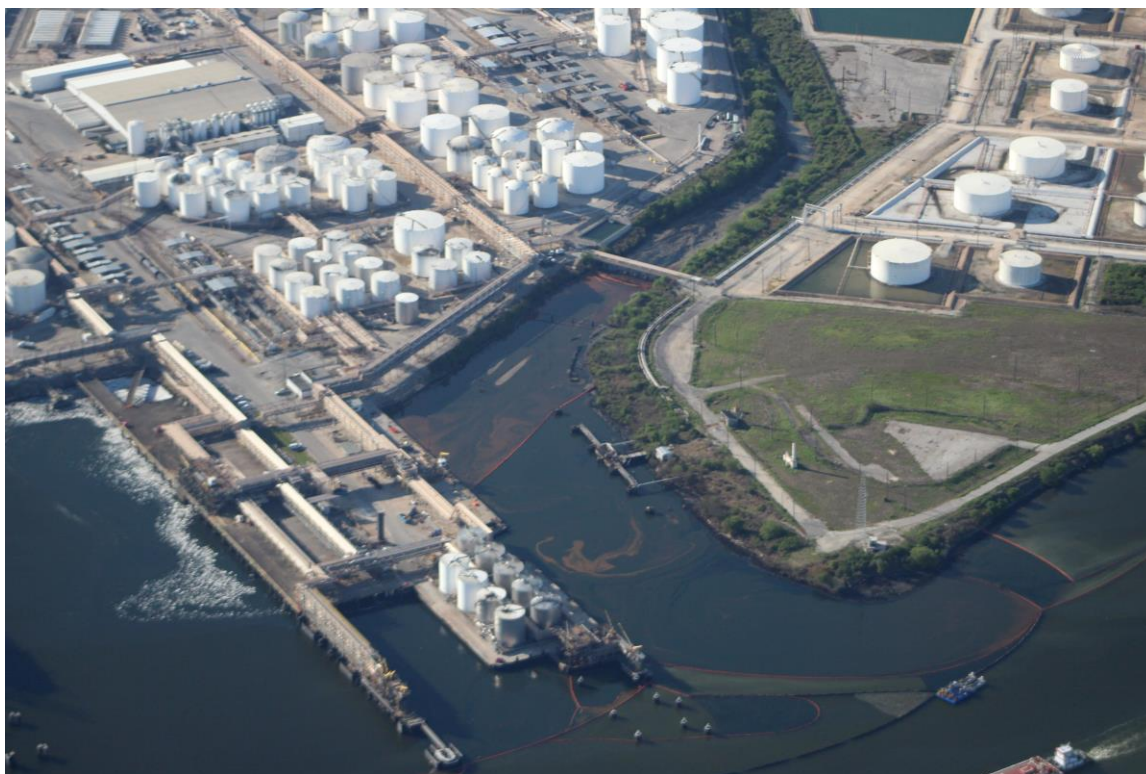
Figure 8: Oblique Image of the Ship Channel Boom Area, 23 March 2019, Flight 10
